Manhole Inspection Summary

Manhole # S21E__039MH

Location Address: **229 FULTON-BRUCE**

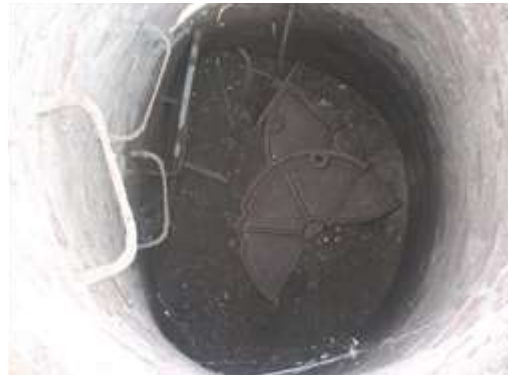
Top View

mh lid broke and fell into mh called 311
comf #407835

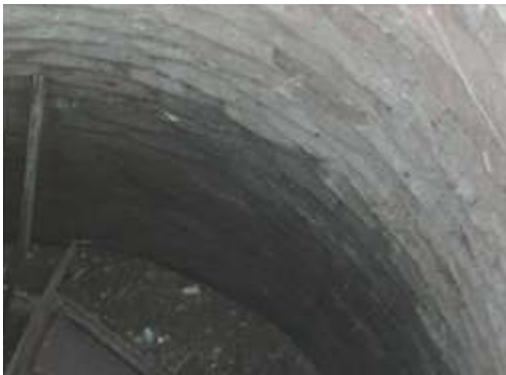
Defect 4

Infiltration: ☐ None ☐ Joint ☐ Cracks ☐ Mortar ☐ Roots ☒ **Wall**

INFILTRATION OF BARREL

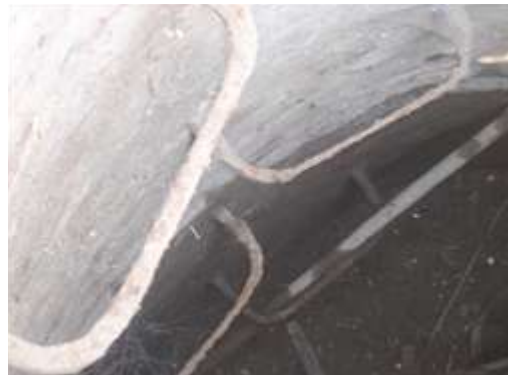
Defect 3

Steps Count: **4** Missing: **0** ☒ **Corroded**

CORRODED STEPS

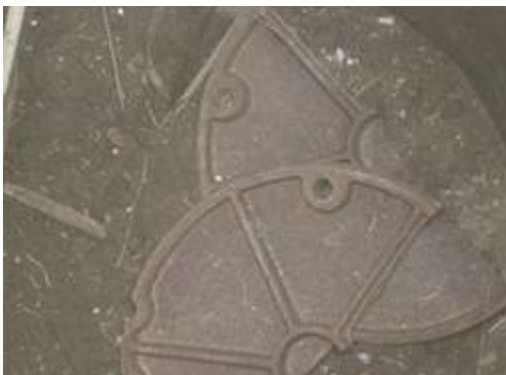
Defect 2

Type: **Sanitary** Condition: **Broken** Cover Material: **Cast Iron**

CHANNEL DEBRIS BROKEN COVER

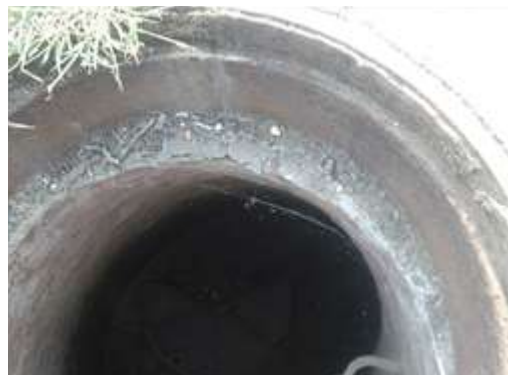
Defect 1

Frame Offset: **2** (in.) Condition: ☒ Sound ☐ Cracked ☐ Leaks

FRAME OFFSET

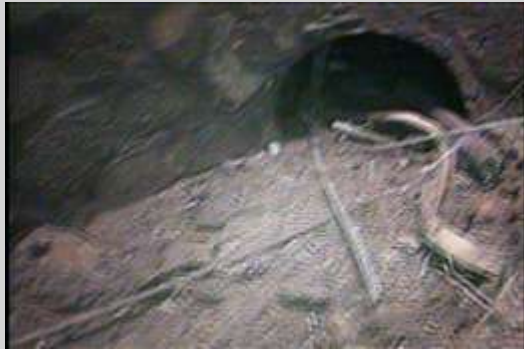
12 O'Clock Outflow

8 in. Circular Gravity Sewer
Pipe Out @ 12 O'Clock

Deposits: ☐ None ☐ Mud ☐ Sludge ☒ **Debris** ☐ Grease

Silt Depth: **3** (in.) Deposits Extent: **Medium**
